# Manhole Inspection Summary

Manhole # S31G\_\_042MH

Insp Date: **8/1/08 12:05 PM**

**Location** Address: **cross from 22 s greene st**

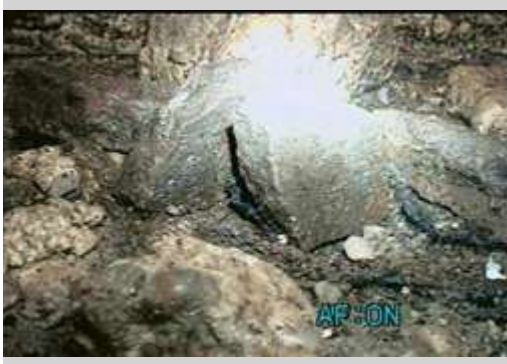
Misc

bench debris

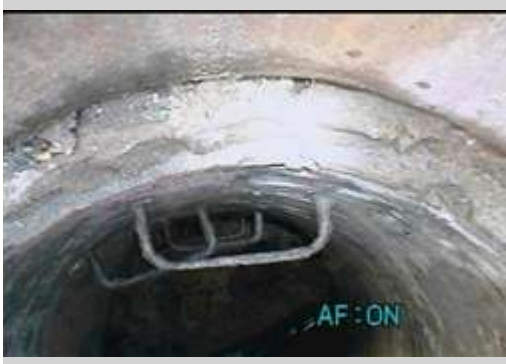
Defect 3

Offset: **2.5** (in.)

offset

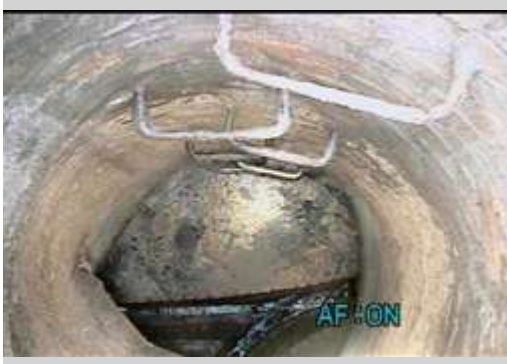
Defect 2

Count: **6** Missing: **0** ☒ **Corroded**

corroded steps

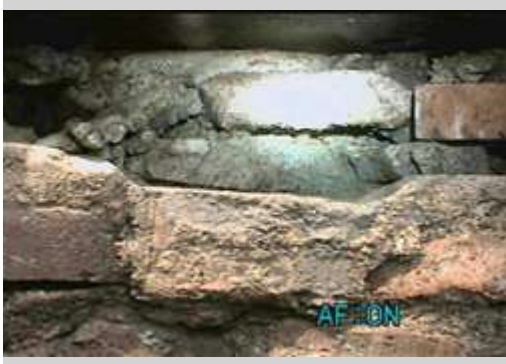
Defect 1

Condition: ☐ Sound ☐ Cracked ☐ Root Intrusion ☒ **Loose Brick** ☒ **Deteriorated**

chimney loose bricks, cracked and deteriorated , frame adj
